Prevent Water Intrusion at Windows  
(Stucco Clad Buildings)

Save Time and Money with this Method

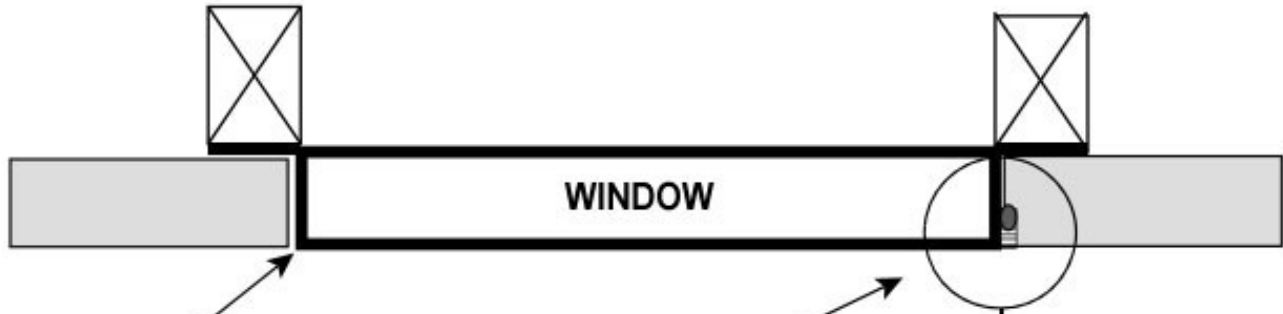
1. PROBLEM - Wind driven rain can enter here (between window and stucco)

2. SOLUTION - Repair by:

a. Small saw kerf ( $\frac{1}{8}$ " wide or less x  $\frac{1}{2}$ " deep) at juncture of frame & stucco

b. Install Adeka Ultraseal® 4mm string

c. Seal joint with Dow Corning Silicone long term flexible sealant

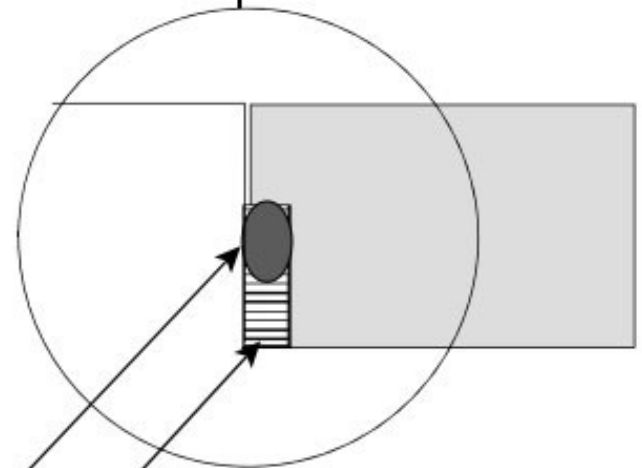
Adeka Ultraseal® KM 4mm

Sealant

Detail and procedure as outlined in Mr. Bucholtz's "Techniques and Comments" newsletter number 191
